| Grundartún 4, Hvammstanga | | | Teikn nr:<br><b>P-100</b> |
| Tengigrindur og ofnatafla<br>Skýringar | | | Frumstærð:<br><b>A2</b> |

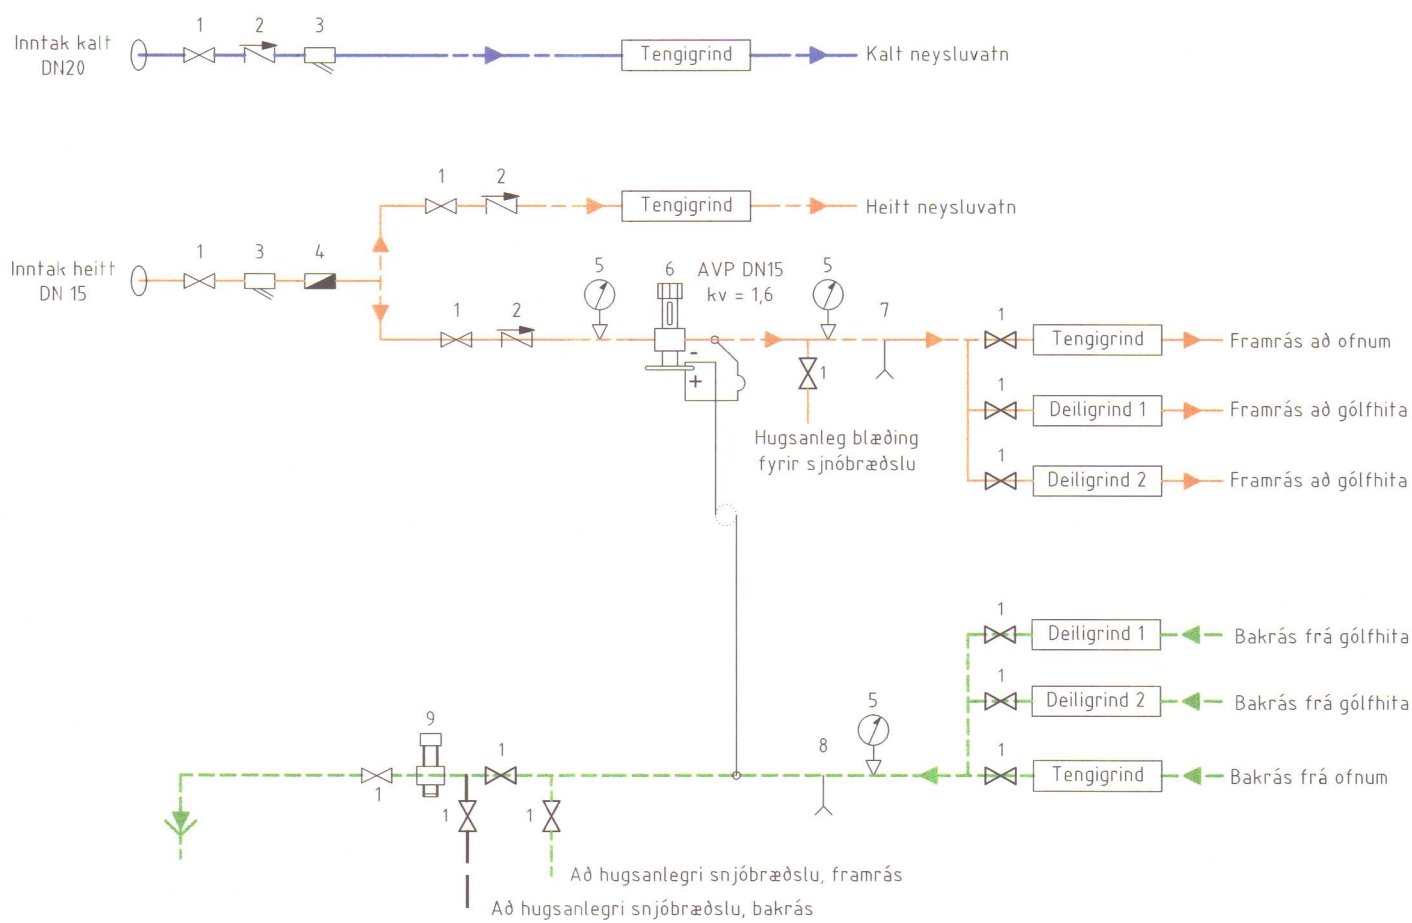
Lagnagrind:

1. Kúluloki
2. Einstreymisloki
3. Sía
4. Rennslis- og magnmælir
5. Hita- og þrýsimælir
6. Mismunaprýsijafnari AVP (DN15 KV=1,6)
7. Öryggisloki
8. Tæming
9. Slaufuloki
10. Hítastýrður AVTB EDA RAVV lokið 0-30°C
